NIUSAT Status after Two Years in Orbit

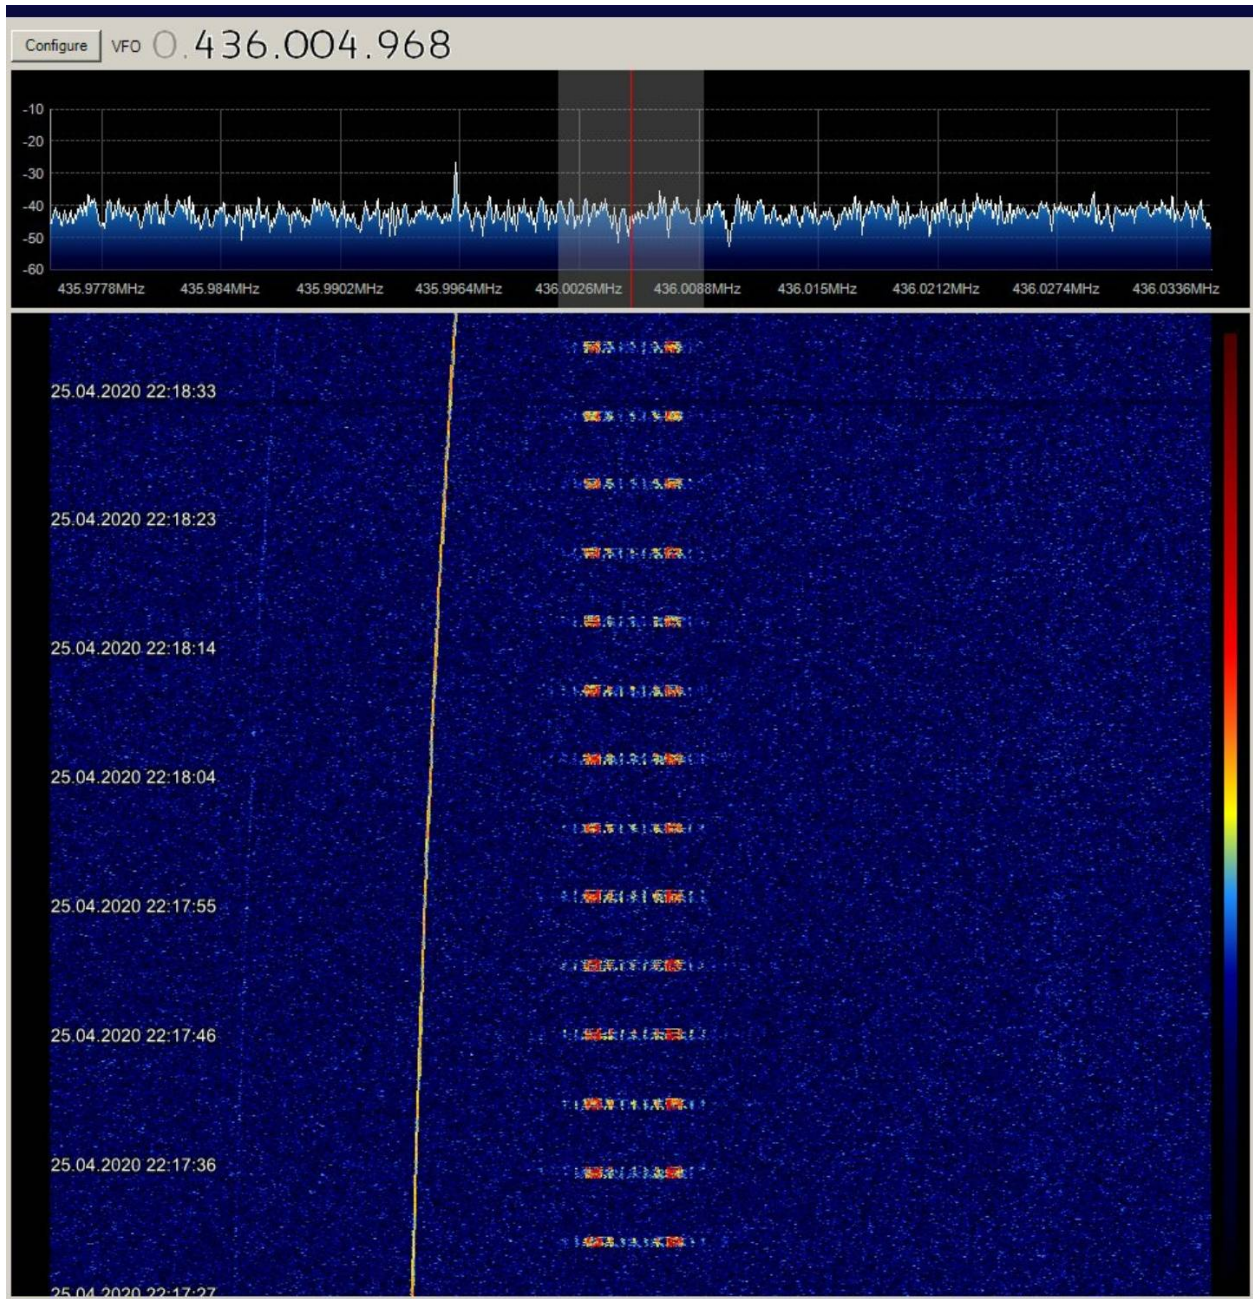
NIUSAT has been received at Belarus Ground station (Europe) for the last five days. On 26th Apr 2020 they received the Rx for the whole 7 orbits. From the spectrum waterfall image it is observed that the satellite is transmitting at 5sec interval which indicates that NIUSAT satellite is in normal operation mode (Battery Charged above 7.1V) after two and half years in orbit.
